Manhole Inspection Summary

Manhole # S04GG2002MH

Insp Date: **7/29/06 9:38 AM**

Location Address: **3302 CLARAN RD**

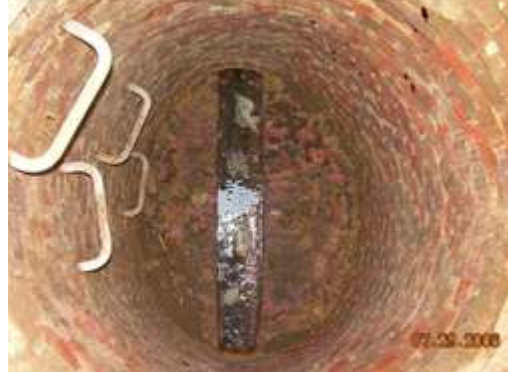
Top View

Evidence of surcharge - Bench debris.
Channel debris.

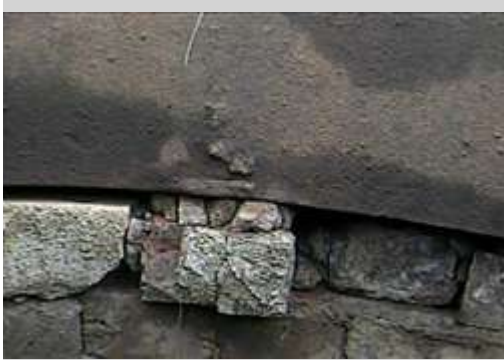
Defect

Frame leaks. Adjustment deterioration,
loose brick, and infiltration.

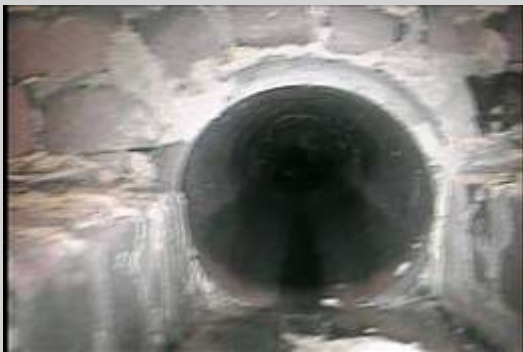
8 in. Circular Gravity Sewer Pipe Out @ 12 O'Clock

Infiltration: **Evidence** Pipe Seal Cond: **Unknown**

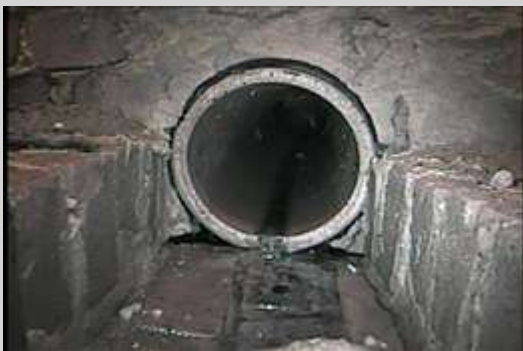
6 in. Circular Gravity Sewer Pipe In @ 6 O'Clock

Comments **The I6 pipe seal is not flush to the pipe.**
